**Cony Flatiron Assessment**  
**5 September, 2007**

**Summary of Observations  
Historic Building Fabric  
Cony “Flatiron” Building  
Augusta, Maine  
5 September, 2007**

CONY FLATIRON RE-USE  
AUGUSTA, MAINE

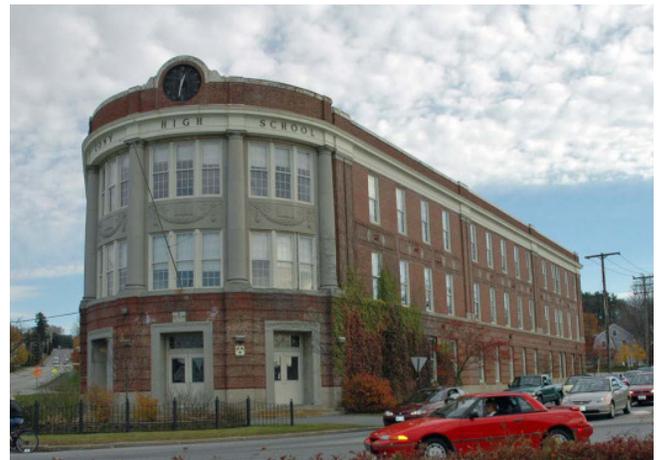
*The Cony High School today. Note that windows have been removed and the openings filled in with brick.*

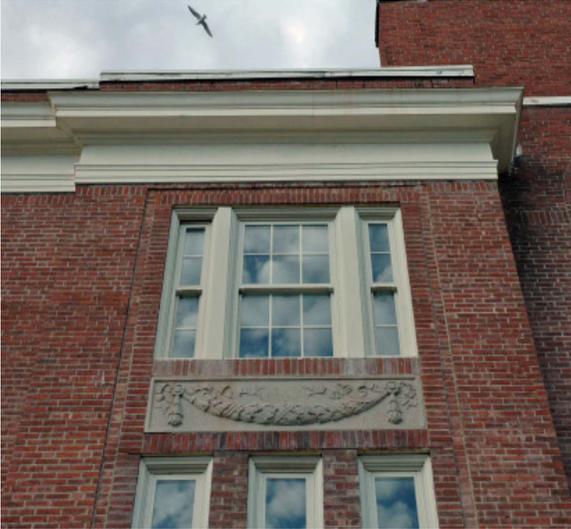
*Decorative, cast stone panels embellish the facades of the Flatiron Building. All of the original wood window sash were replaced with insulated, aluminum window units in 1984.*

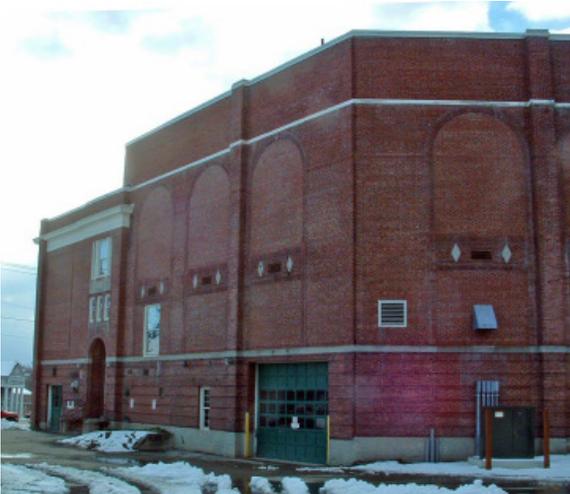
*The rear of the building. The wall steps up to accommodate the balcony and ceiling of the Auditorium. The large, arch-topped windows were removed and the openings infilled with brick in 1984.*

A number of openings from the original design were in-filled during the 1984 renovation. It may be possible to re-open these openings with out the need for seismic reinforcing; however additional review will be required.

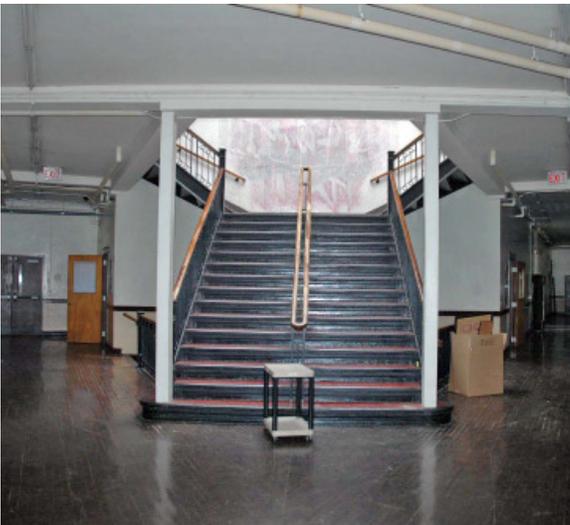
*Steel columns were added to the stair hall in 1984.*

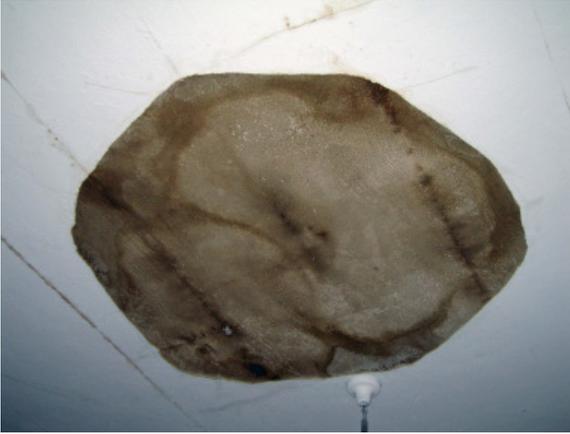
*This water damage in the plaster ceiling of the Auditorium was likely the result of a roof leak.*

The floor/ceiling assembly appeared to be in good condition. Where visible, the existing wood structure appeared to be in very good condition and of good quality. Isolated areas of water stains, cracked plaster, and peeled paint were noted on the ceiling. Several areas where the hardwood floors had bulged were also noted. These conditions appear to be attributed to water leaks associated with the unit ventilators.

In general the water damage noted on the floors and ceiling appeared to be from isolated plumbing leaks, additional review of these areas should be completed to confirm this assumption. Repairs to these areas will primarily be cosmetic.

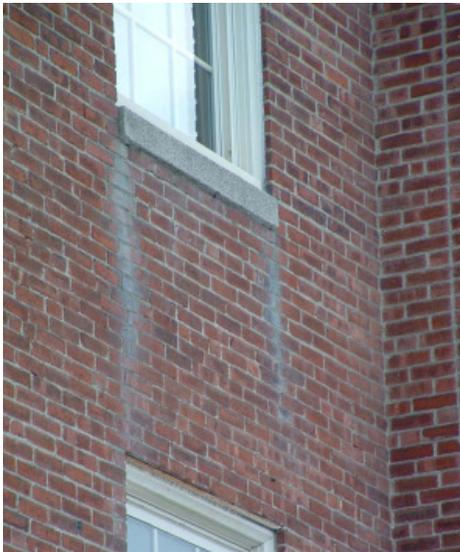
*Water runoff from the cast stone sills has left staining on adjacent brickwork.*

- Clean, repair exterior masonry. The brick masonry requires cleaning, and some repointing. Bricks are in good condition so a water repellent is not recommended.
- Repair cast stone, concrete sills. Weathering has left aggregate visible on these surfaces. The pitted surfaces will collect water, further accelerating deterioration.
- Paint rusting lintels over windows.
- Repair to plaster ceiling above auditorium. Water damage was most likely from a roof leak (confirm before repairing plaster).
- Repair damaged plaster.
- Remove vines from exterior.

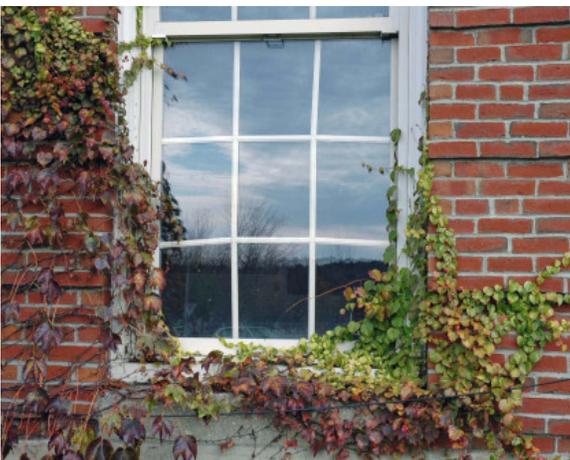
*Vegetation should be removed from the building exterior.*
