GODBOUT, RENE

SUBMIT THE FOLLOWING COMPLETED FORM TO YOUR LOCAL PLUMBING INSPECTOR

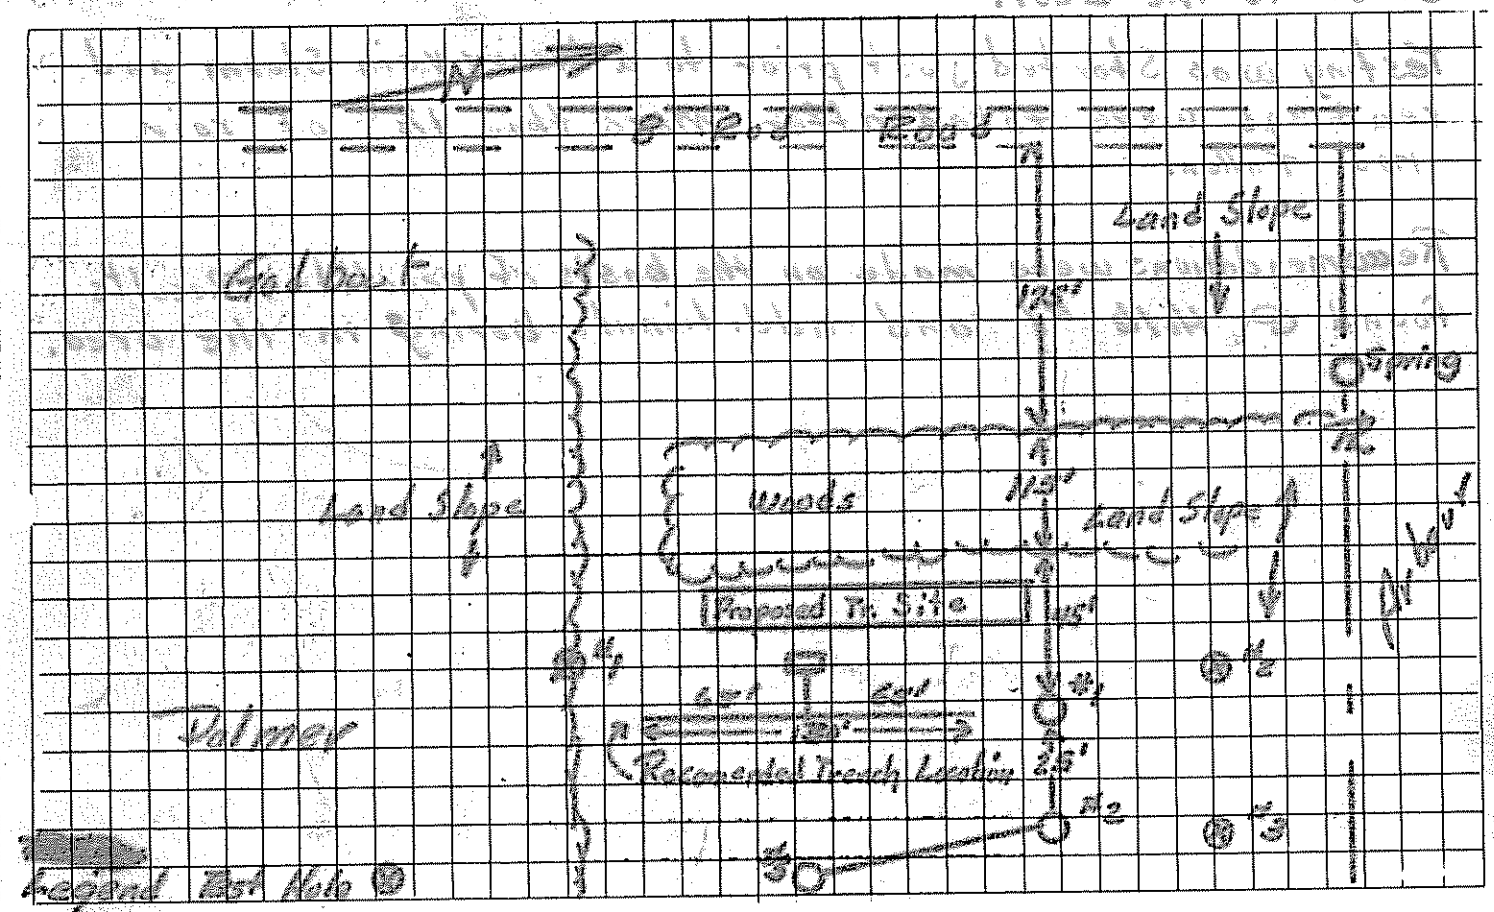
SKETCH: LOCATION OF BUILDING DISPOSAL SYSTEM, TERRAIN FEATURES, PERCOLATION HOLES, WATER SUPPLIES, ETC.

5'+ Depth to Water Table
5' none Depth to Bedrock Holes 2 & 3 See explanation
20"+ Depth to Clay or other impervious strata

Remarks: Bedrock was encountered at 30" at perk hole #1 The soil in this area is a well draining Loamy Sand as determined from additional test holes 1 and 2, Ledge Soundings taken in the area indicate bedrock from 2½' to 5 feet. Trench may have to be adjusted To 100' to South To reduce Northerly Trench.

Perk Holes 2 and 3 were taken in a depressed area and The soil was found to be silty Loams Test holes 3 and 4 (not shown on reverse side) indicate the same Soil Conditions exist to the East.

Recomendations were made on the basis of percolation Results found @ Hole #1 and additional borings in the area.
