Rowe, Maynard

SUBMIT THE FOLLOWING COMPLETED FORM TO YOUR LOCAL PLUMBING INSPECTOR

OWNER Maynard Rowe
STREET Bolton Hill Rd
CITY Augusta MAINE
TEL. NUMBER —

LOCATION OF PROPOSED INSTALLATION
STREET Bolton Hill Rd
CITY Augusta MAINE
TEL. NUMBER

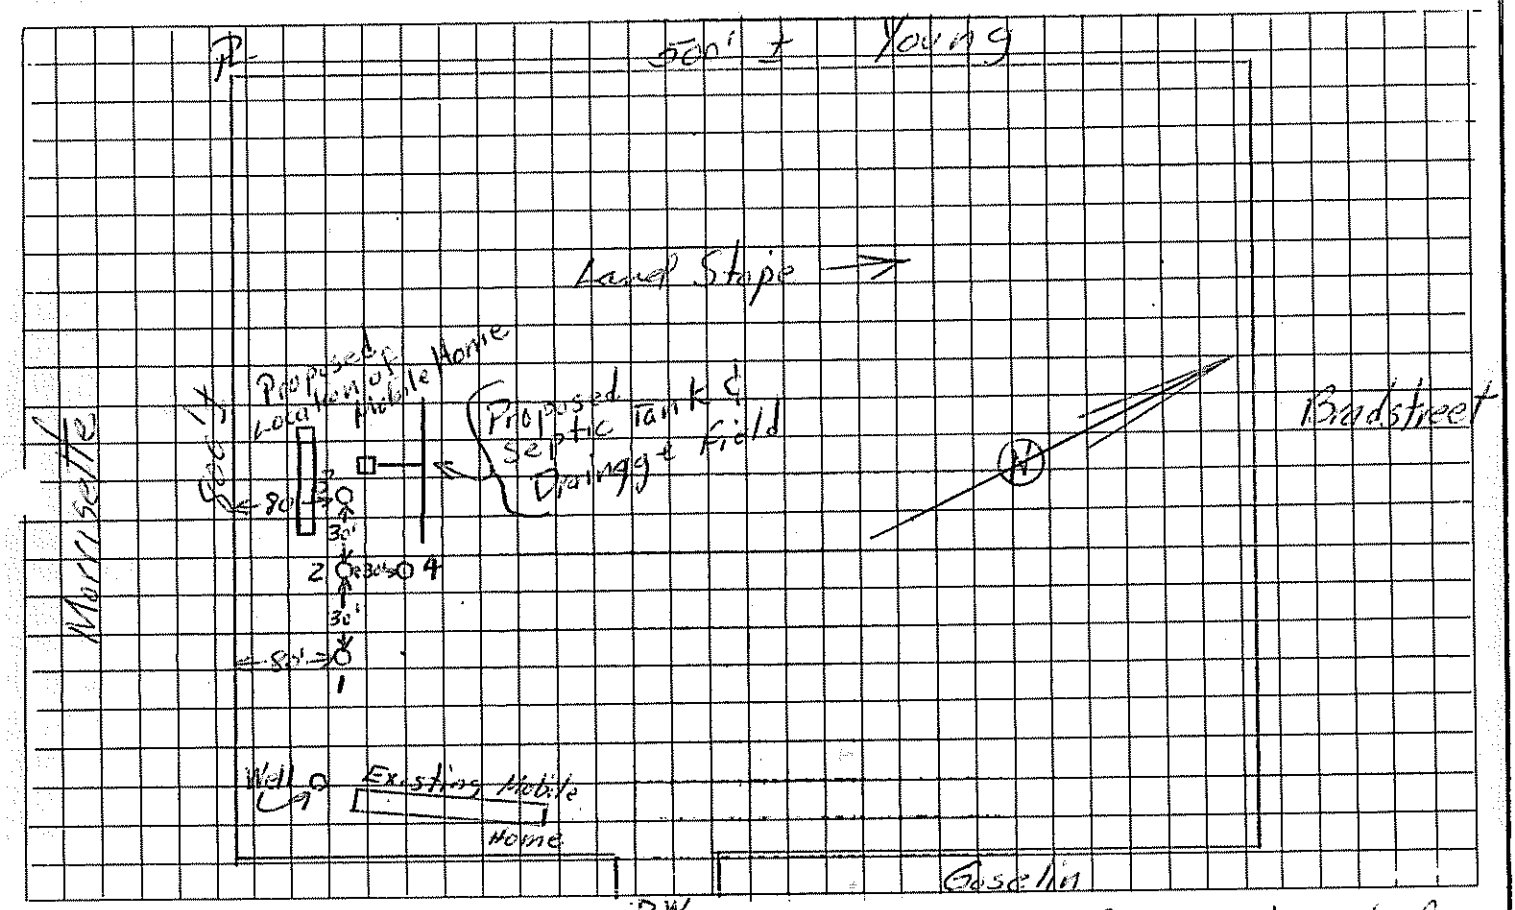
SKETCH: LOCATION OF BUILDING DISPOSAL SYSTEM, TERRAIN FEATURES, PERCOLATION HOLES, WATER SUPPLIES, ETC.

5'+ Depth to Water Table
5'+ Depth to Bedrock
5'+ Depth to Clay or other impervious strata

HOLE	HOLE DEPTH	TIME START	TIME FINISH	DEPTH OF WATER SURFACE START	DEPTH OF WATER SURFACE FINISH	ELAPSED TIME	TOTAL DROP OF WATER	PERCOL. RATE MINUTES/INCH
#1	36 in.	5:43	6:21	18 in.	21½ in.	38 min.	35 in.	10.9 min/in
#2	36 in.	5:44	6.01	19 in.	23 in.	17 min.	4 in.	4.1 min/in
#3	36 in.	5:45	6:15	19 in.	23¼ in.	30 min.	4.25 in.	7.1 min/in
#4	36 in.	5:45	6:00	19¾ in.	24½ in.	15 min.	4.75 in.	3.2 min/in
						AVERAGE RATE		6.3 min/in

REMARKS Recomend 85' of Absorption Trench as Shown
