Bld Permit 1470
Louten, Daniel

SUBMIT THE FOLLOWING COMPLETED FORM TO YOUR LOCAL PLUMBING INSPECTOR

Map 8 Lot 54

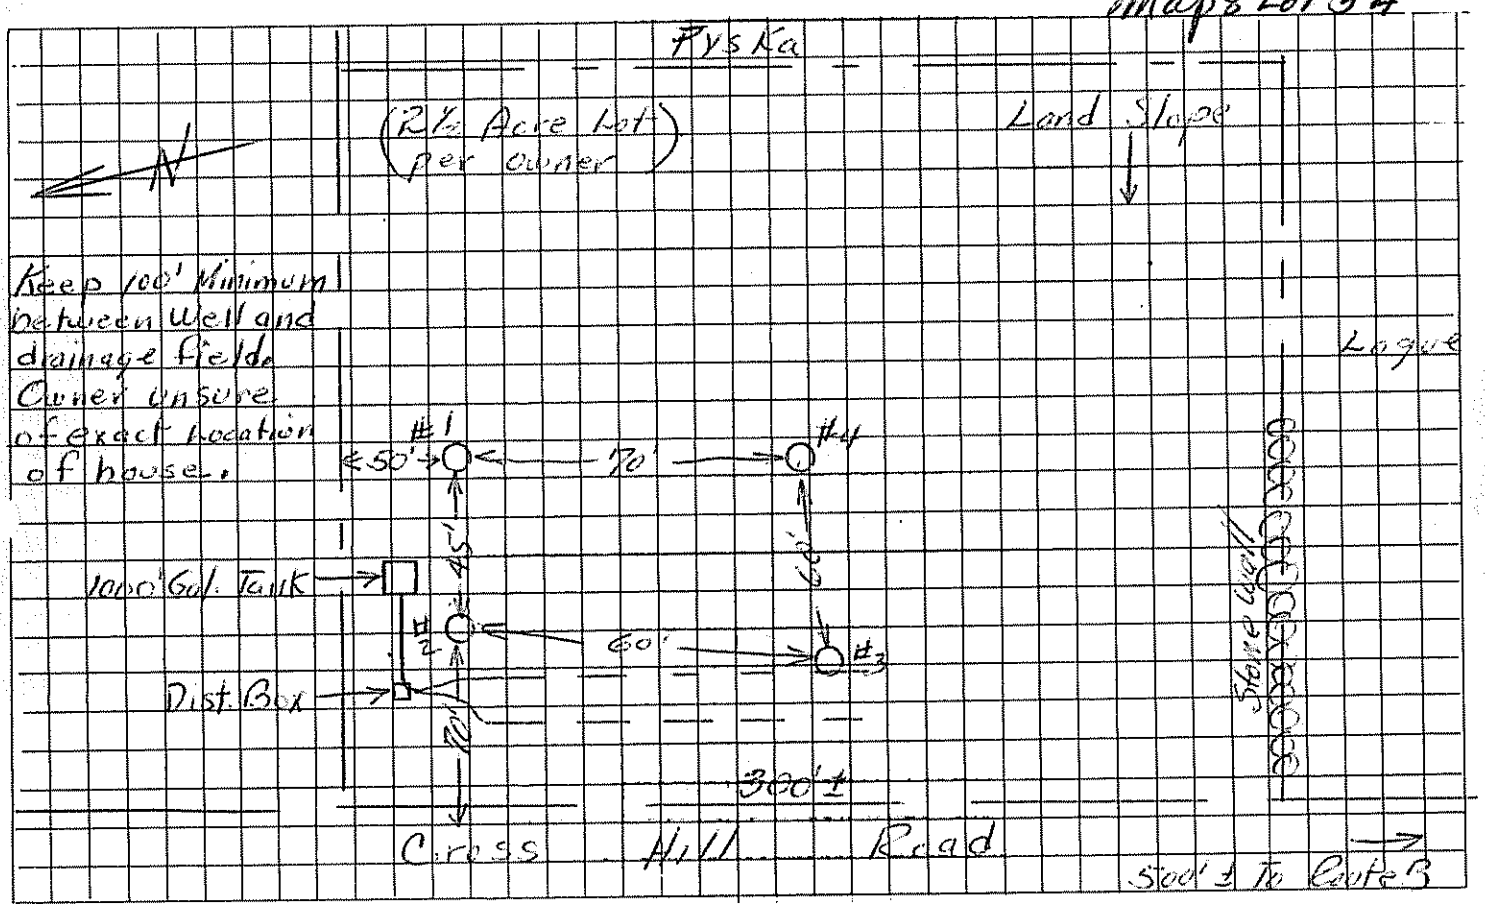
SKETCH: LOCATION OF BUILDING DISPOSAL SYSTEM, TERRAIN FEATURES, PERCOLATION HOLES, WATER SUPPLIES, ETC.

5'+ Depth to Water Table
5'+ Depth to Bedrock
5'+ Depth to Clay or other impervious strata
*Large Rocks (other Sites shallower)

REMARKS Recommend 2-60' Absorption Lines as shown. This area is Very Rocky and difficult to work. Care needed in Installation.
