SUBMIT THE FOLLOWING COMPLETED FORM TO YOUR LOCAL PLUMBING INSPECTOR

WARREN, HAROLD

DATE June 25 1972	OWNER Harold Warren
NUMBER OF BEDROOMS [illegible]	STREET RED #2 Augusta
SIZE OF SEPTIC TANK	CITY Chelsea MAINE
TYPE OF SOIL Fill	TEL. NUMBER 582-2686
Test Performed by [illegible] P.E. #1638	LOCATION OF PROPOSED INSTALLATION
Local Plumbing Inspector's Signature	STREET Thomaston Road
	CITY Augusta MAINE
	TEL. NUMBER

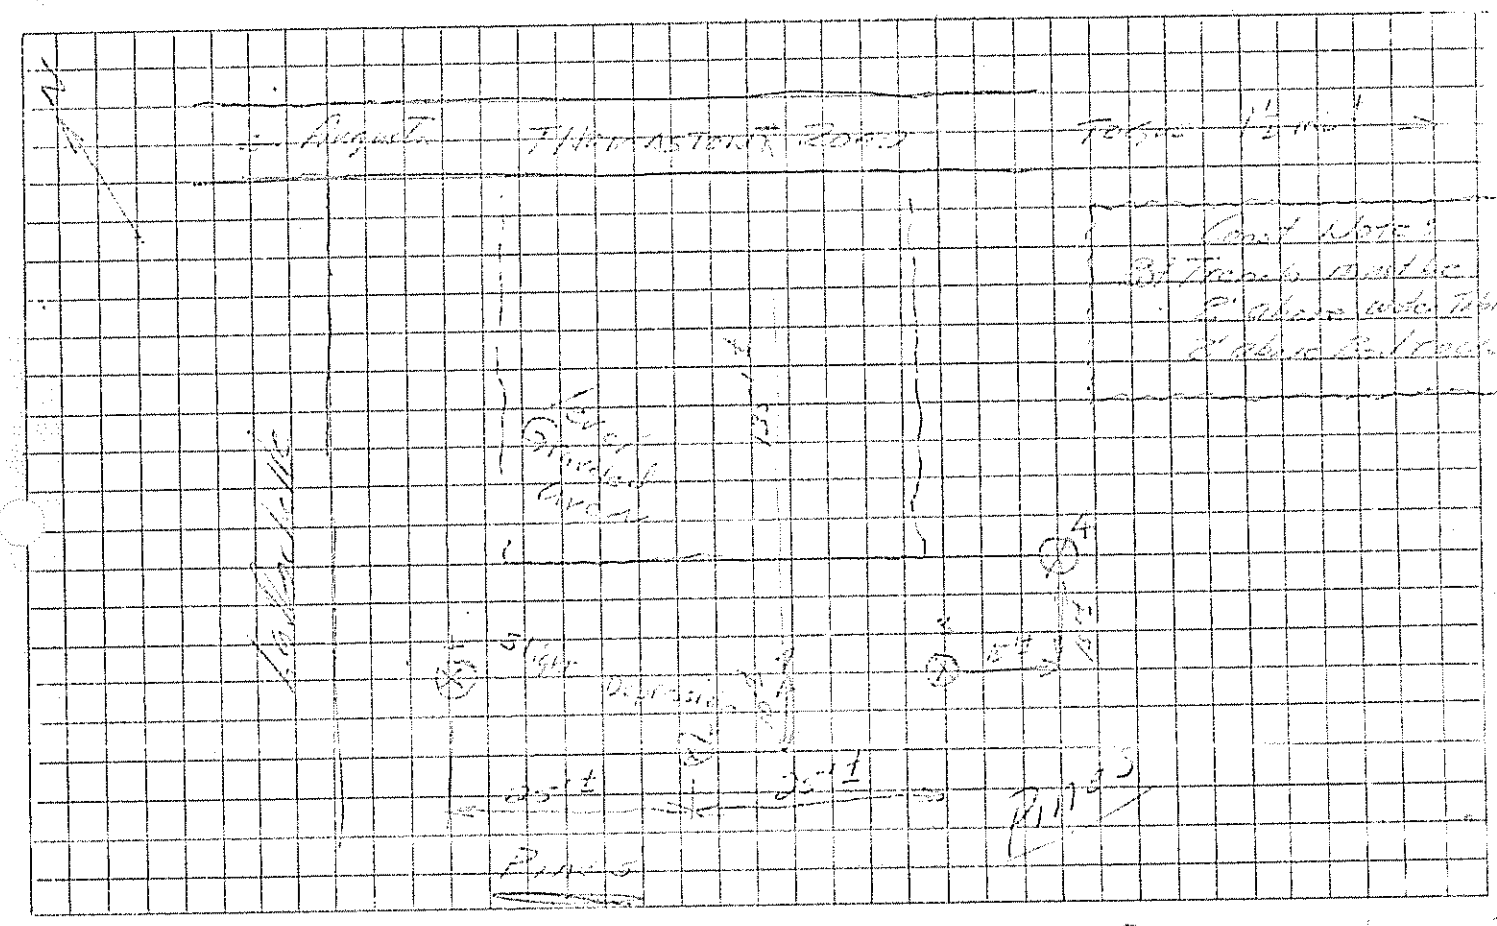
SKETCH: LOCATION OF BUILDING DISPOSAL SYSTEM, TERRAIN FEATURES, PERCOLATION HOLES, WATER SUPPLIES, ETC.

— Depth to Water Table
— Depth to Bedrock Not found, ledge in area
— Depth to Clay or other impervious strata

REMARKS Bouldery Clay [illegible] Pine growth
Water in bot of holes 1 & 2 @ 17.45

HOLE	HOLE DEPTH	TIME START	TIME FINISH	DEPTH OF WATER SURFACE START	DEPTH OF WATER SURFACE FINISH	ELAPSED TIME	TOTAL DROP OF WATER	PERCOL. RATE MINUTES/INCH
#1	24" Bedrock — in.	13.01	13:46	— in.	3 5/8 in.	45 min.	3.62 in.	12.4 min/in
#2	23" bedrock — in.	13.02	13:46	— in.	3 1/8 in.	44 min.	3.13 in.	14.0 min/in
#3	20" bedrock — in.	13:02	13:47	— in.	5 1/2 in.	45 min.	5.5 in.	8.2 min/in
#4	30" Hard Pan — in.	13:03	13:47	— in.	6 1/2 in.	44 min.	6.25 in.	7.1 min/in
						AVERAGE RATE		10.4 min/in

Maine Plumbing Code Rsg's 111' Trench
