**Cony Flatiron Assessment**  
**5 September, 2007**

**Summary of Observations  
Historic Building Fabric  
Cony “Flatiron” Building  
Augusta, Maine  
5 September, 2007**

CONY FLATIRON RE-USE  
AUGUSTA, MAINE

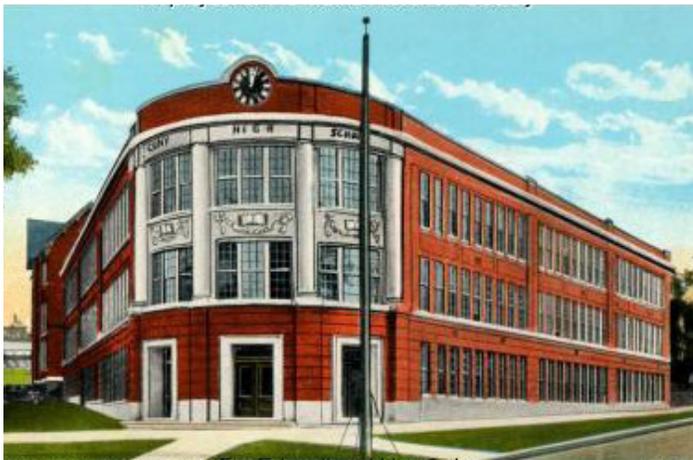
*An early postcard showing the Cony High School. Visible at the left is part of the 1881 Cony Free High School building.*

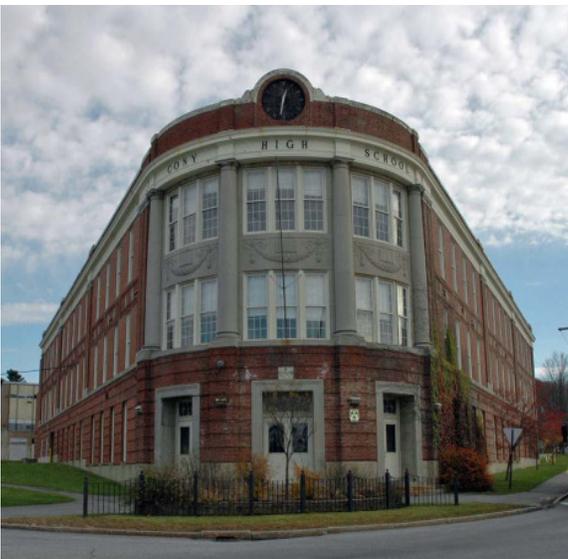
*The front of the building is on the point of the “flatiron” and faces east towards a traffic circle.*

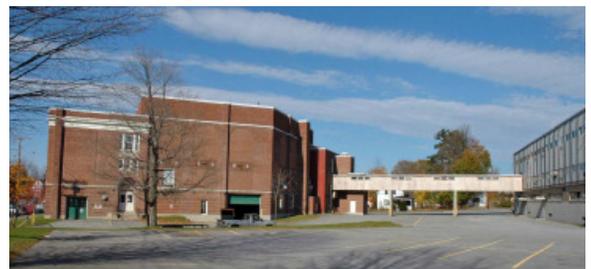
*Photograph of the rear of the Flatiron Building showing the connecting enclosed bridge that leads to the 1963 addition, far right.*

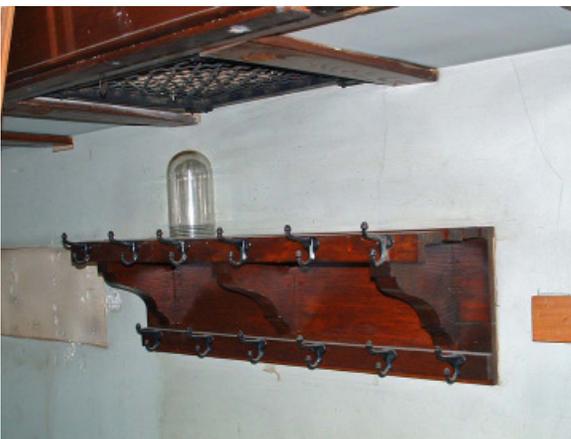
*Coat rack and hat shelves like this one were installed in the classroom closets. A shaft above the metal grille provided ventilation.*

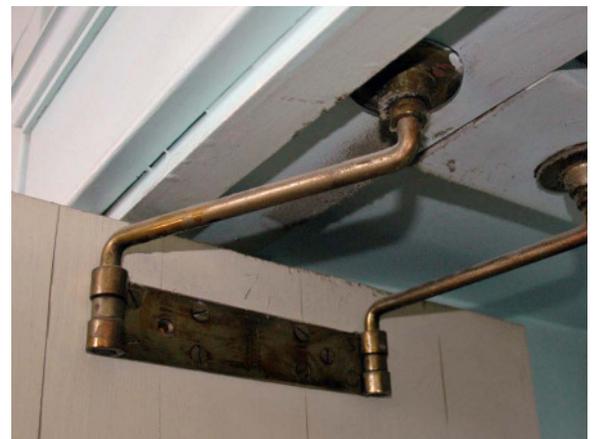
*Original pivoting hinges remain in a few of the classroom closets.*

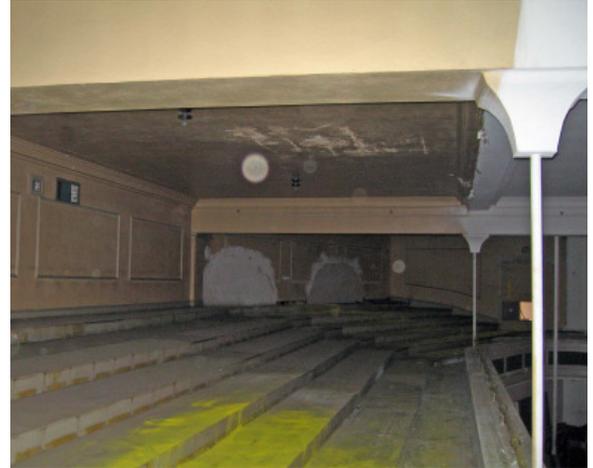
*The balcony in the third floor auditorium retains risers for the since-removed fixed seating. Also visible is the wall of the projection booth and the infilled arched openings which once held windows.*

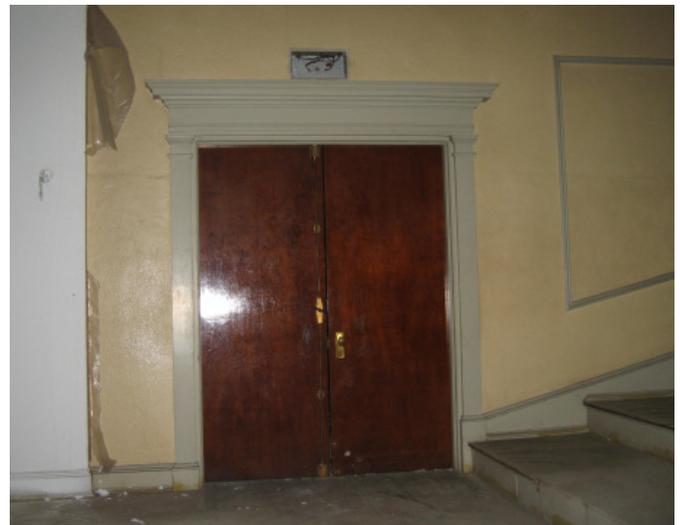
*Original Auditorium doors, trim and hardware survive in the balcony. Also note the early (possibly original) paint scheme and raised panels on the adjacent wall.*

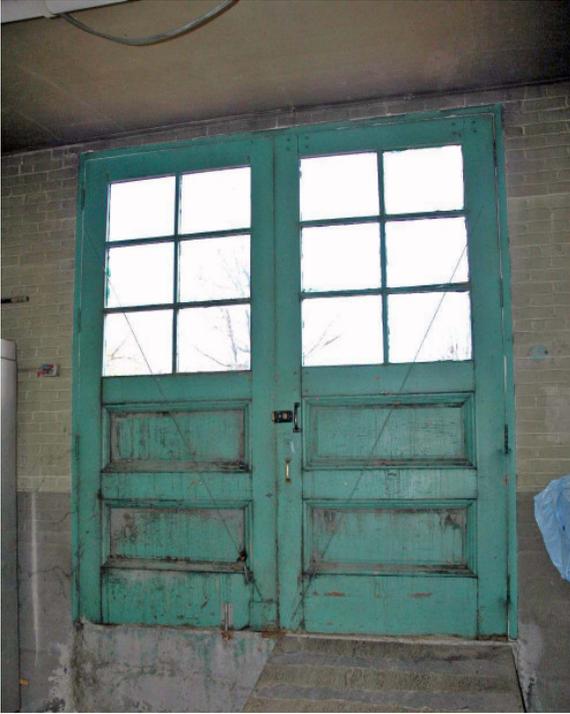
*Most of the original doors have been removed from the building; these doors are a rare survivor.*

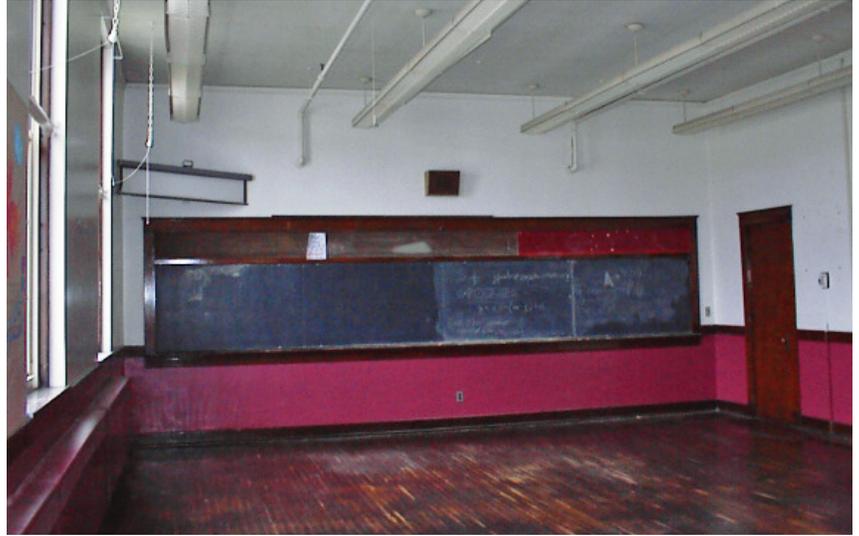
*This classroom retains original slate chalk boards and their trim; a wood chair rail and baseboard; and an original door and frame.*
